RE: Arlington Parks Playground Assessment and Recommendation Report

PLAYGROUND ASSESSMENT AND RECOMMENDATION REPORT

PLAYGROUND NAME & ADDRESS: Buzzell Field, 29 Summer Street

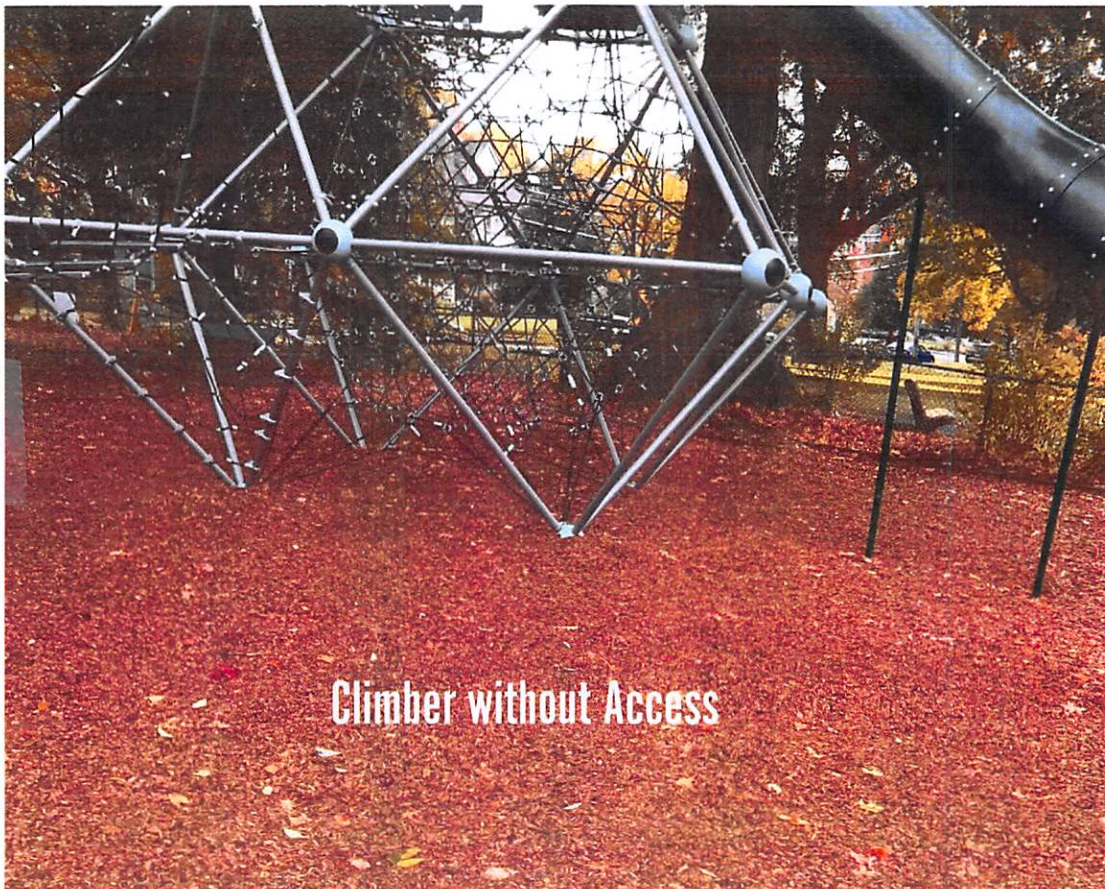
Climber without Access

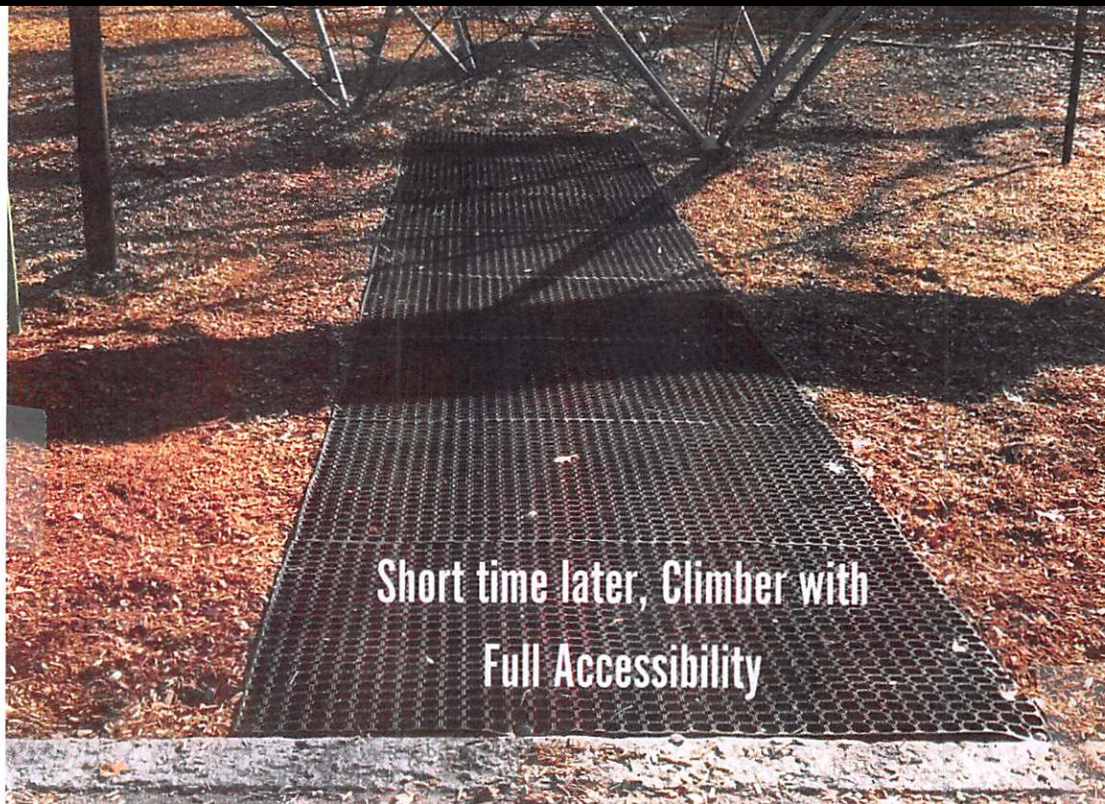
Short time later, Climber with
Full Accessibility

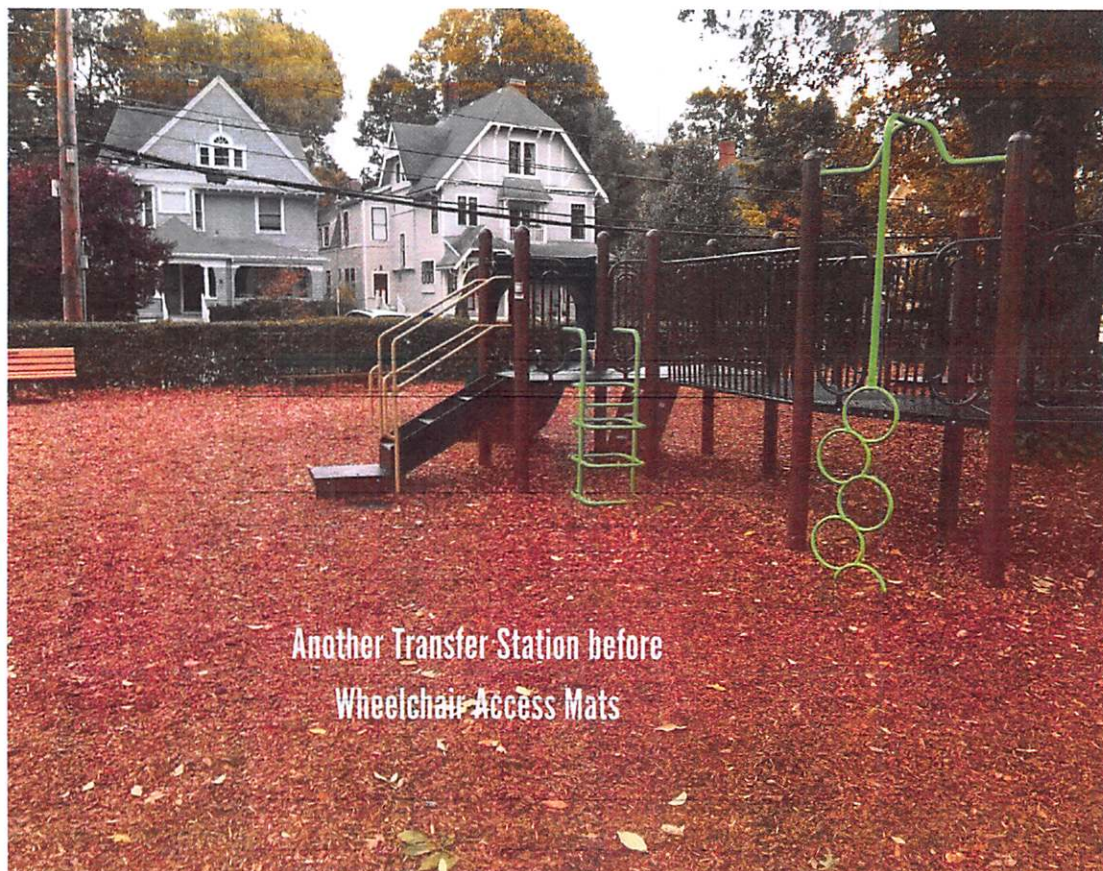
Another Transfer Station before
Wheelchair Access Mats
